PROBLEM: With the increased adoption of composite materials and innovative coatings in aircraft construction, the need to map damage found during maintenance and manufacturing onto CAD models has become essential. Historical approaches require extensive training and/or the use of expensive specialized equipment and can be very manual in nature

WHAT NLIGN PROVIDES?

Solution:

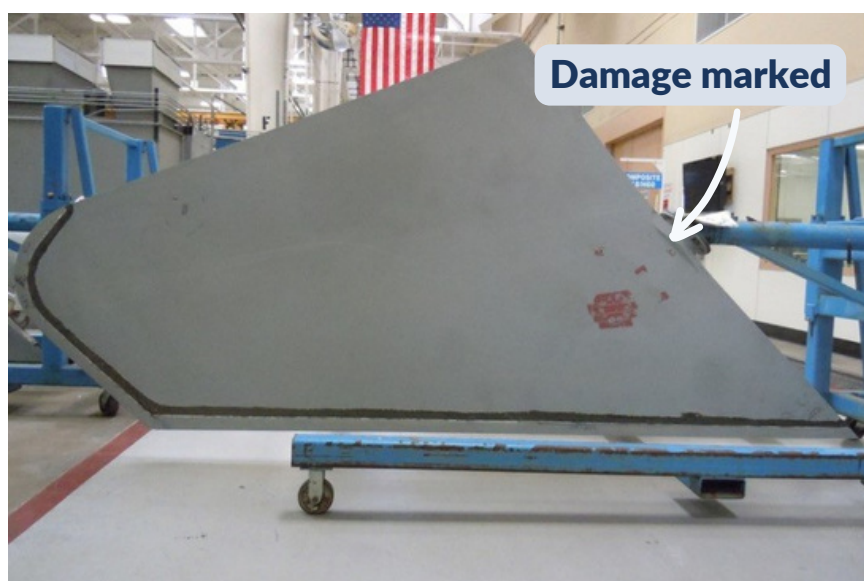
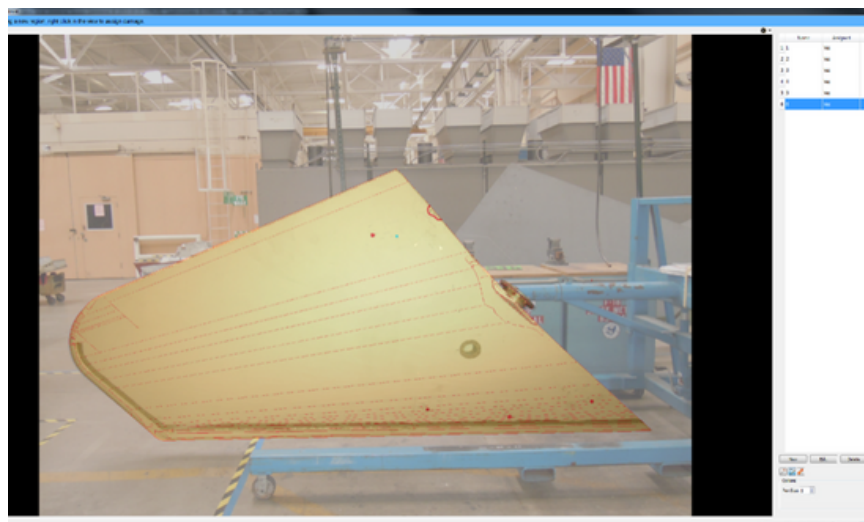
These images show the damage to the mapping process. First, a photograph is taken of the damage. Next, the photograph is aligned with a CAD model. Finally, the damage in the photograph is mapped onto the CAD model

The process begins with the inspector marking the damage on the aircraft with a pen or another tool. The user then takes a picture of the damage and surrounding area. Once brought into the NLign software, this picture is aligned to a model of the structure using photogrammetric techniques. Pen annotations can also be extracted from the photograph and mapped onto the 3-D part.
